Manhole Inspection Summary

Manhole # S43II_059MH

Insp Date: **3/11/08 12:21 PM**

Location Address: **1503 BETHEL ST**

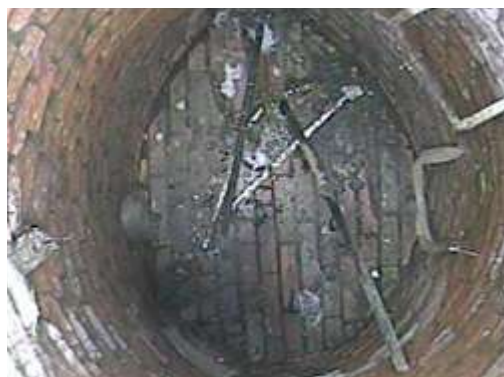
Defect 2

Steps Count: **4** Missing: **0** ☒ **Corroded**

STEPS CORRODED

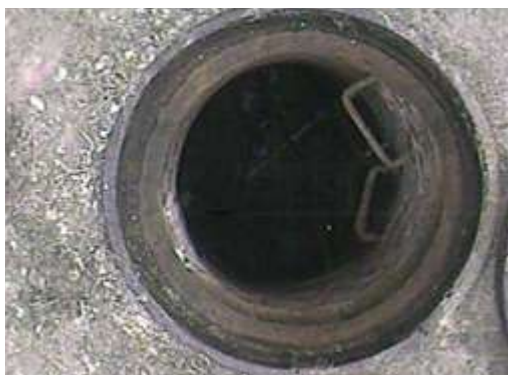
Defect 1

Frame Offset: **1** (in.) Condition: ☒ Sound ☐ Cracked ☐ Leaks

FRAME OFFSET

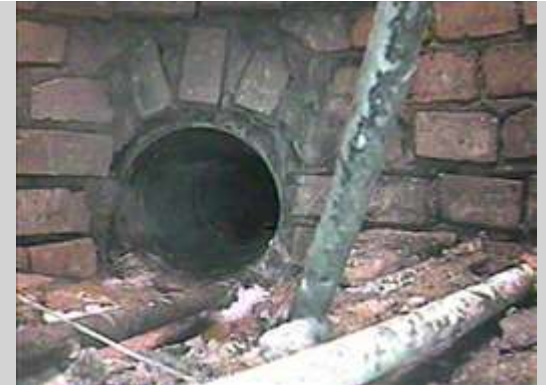
12 O'Clock Outflow

6 in. Circular Gravity Sewer
Pipe Out @ 12 O'Clock

Pipe Material: **Clay** ☐ Pipe Lined

Invert Depth: **7.06** (ft.) Flow Characteristics: **None**

Infiltration: **None** Pipe Seal Cond: **Sound**

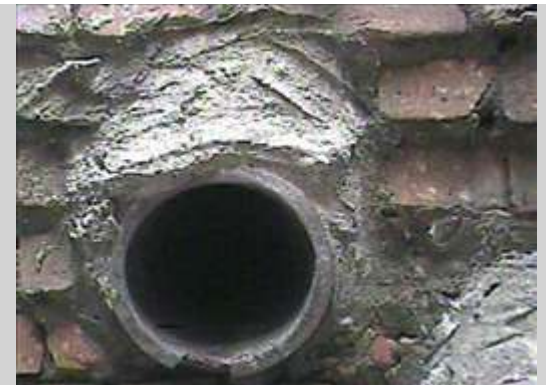
6 O'Clock Inflow

6 in. Circular Gravity Sewer
Pipe In @ 6 O'Clock

Pipe Material: **Clay** ☐ Pipe Lined

Invert Depth: **6.13** (ft.) Flow Characteristics: **None**

Infiltration: **None** Pipe Seal Cond: **Cracked**

Connects To: **House connection / Service line**

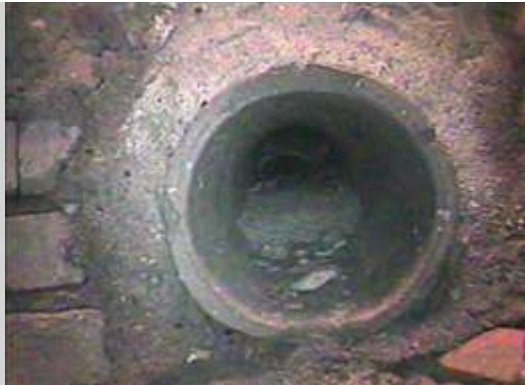
7 O'Clock Inflow

Pipe In @ 7 O'Clock

Deposits: ☐ None ☐ Mud ☐ Sludge ☒ Debris ☐ Grease

Silt Depth: **0** (in.) Deposits Extent: **Light**

Pipe Seal Cond: **Sound**

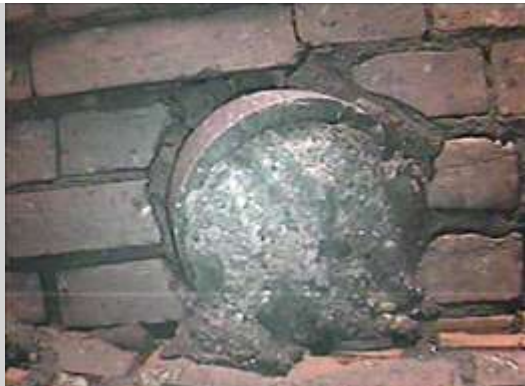
8 O'Clock Inflow

Pipe In @ 8 O'Clock

Deposits: ☒ None ☐ Mud ☐ Sludge ☐ Debris ☐ Grease

Pipe Seal Cond: **Sound**

Connects To: **Stub connection / abandoned**
